Flood Control Project Maintenance
2015 Structure Summary Report
Overall Unit and Item Ratings

San Joaquin County Flood Control and Water Conservation District

Duck Creek Diversion Weir And Control Structure

Flood Control Project Maintenance**Unit Cover Sheet****2015 Structure Inspection Results****San Joaquin County Flood Control and Water Conservation District**

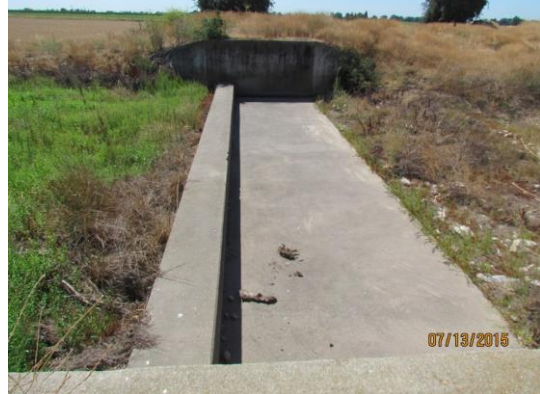
Photo 1 of 1 : ST_2015_NA0017_5_24_20150724_00021.jpg

View of the weir.

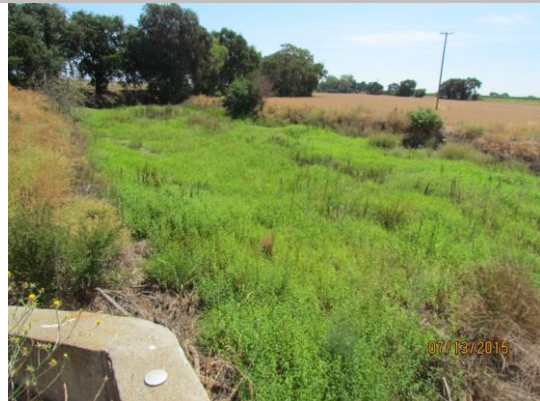
Photo 1 of 2 : ST_2015_NA0017_5_2_20150724_00013.jpg

LM Start	0.00	Rating **	A	Issue No.	2
LM End	0.00	Issue Type +	Ma	Location *	
Category	Structures & Concrete Lined Channels			GPS Latitude/Longitude	
				Start	End
Item	Vegetation & Obstructions			37.938383 °	37.938383 °
				-120.990133 °	-120.990133 °
DWR ID	DWR_NA0017_5_t_2012_2				
Action/Comments					
Inspector Comments: There was minimal vegetation around the structure. The flow was not impeded.

View of the vegetation looking upstream of the weir.

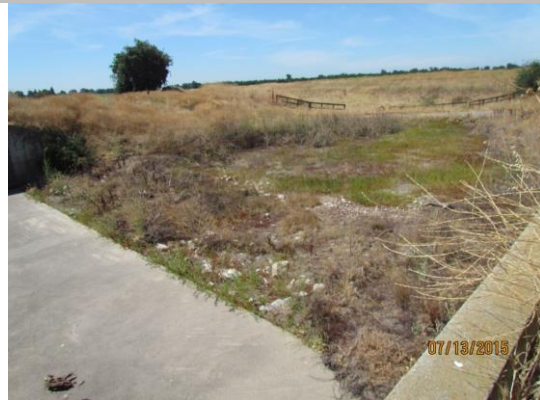
Photo 2 of 2 : ST_2015_NA0017_5_2_20150724_00014.jpg

View of the vegetation looking downstream of the weir.

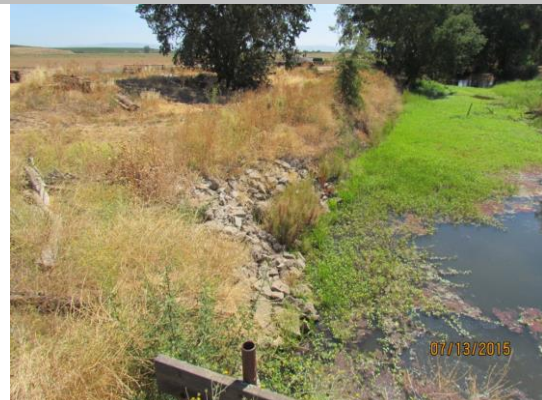
Photo 1 of 2 : ST_2015_NA0017_5_5_20150724_00015.jpg

View of the revetments looking upstream during 2015 inspection.

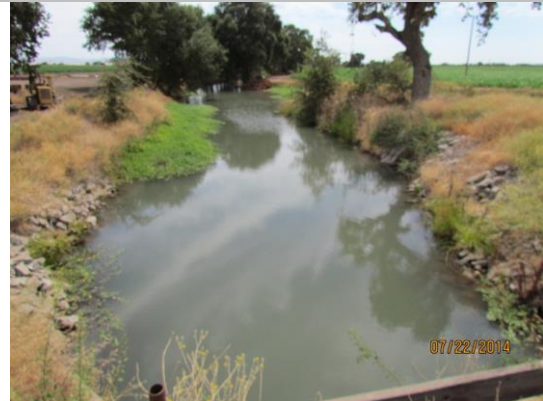
Photo 2 of 2 : ST_2015_NA0017_5_5_20150710_00003.jpg

View of the revetments looking upstream of the structure during 2014 inspection.

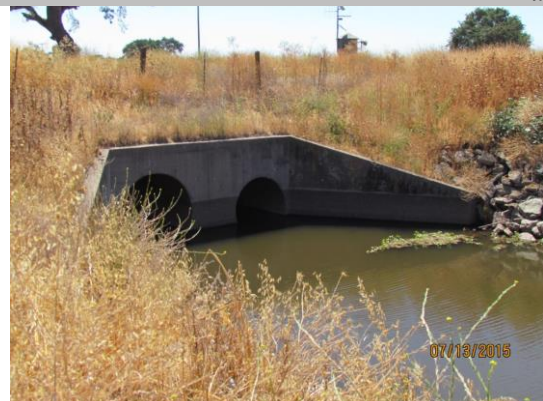
Photo 1 of 2 : ST_2015_NA0017_5_7_20150724_00016.jpg

View of the outlet of the culvert.

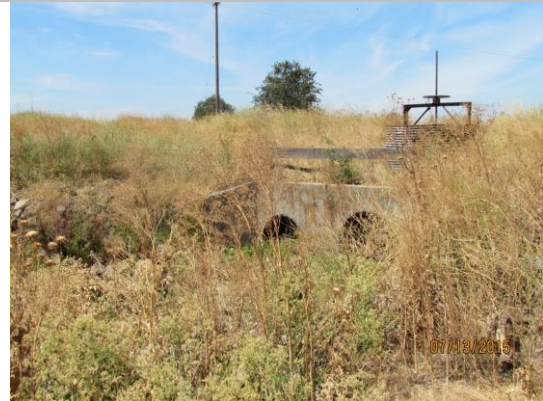
Photo 2 of 2 : ST_2015_NA0017_5_7_20150724_00017.jpg

View of the inlet of the culvert.

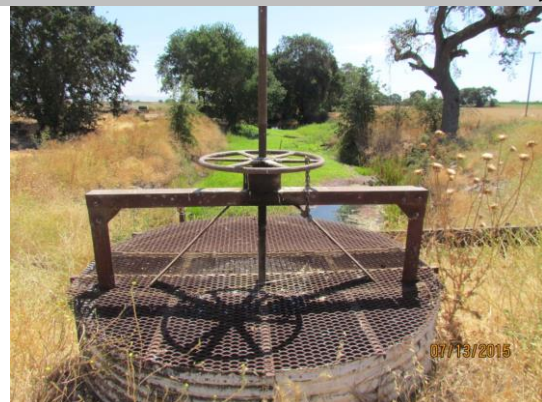
Photo 1 of 1 : ST_2015_NA0017_5_12_20150724_00018.jpg

LM Start	0.00	Rating **	M	Issue No.	12
LM End	0.00	Issue Type +	Ma	Location *	
Category	Structures & Concrete Lined Channels			GPS Latitude/Longitude	
				Start	End
Item	Sluice/Slide Gates			37.938383 °	37.938383 °
				-120.990133 °	-120.990133 °
DWR ID	DWR_NA0017_5_t_2012_12				
Action/Comments					
Inspector Comments: The gates appeared to be in good working condition. The screw gate needs to be maintained properly.

View of the slide gate.

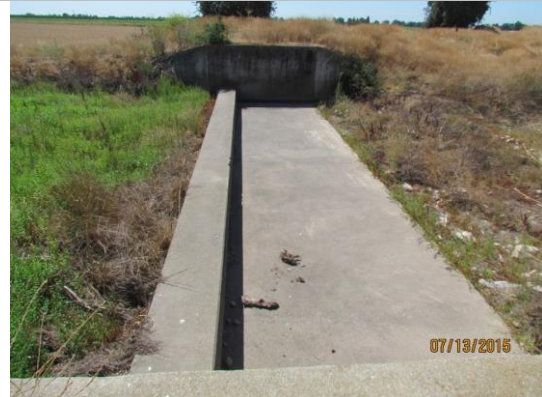
Photo 1 of 2 : ST_2015_NA0017_5_15_20150724_00019.jpg

LM Start	0.00	Rating **	A	Issue No.	15
LM End	0.00	Issue Type +	Ma	Location *	
Category	Structures & Concrete Lined Channels	GPS Latitude/Longitude			
		Start		End	
Item	Concrete Surfaces	37.938383 °		37.938383 °	
		-120.990133 °		-120.990133 °	
DWR ID	DWR_NA0017_5_t_2012_15				
Action/Comments					
Inspector Comments: The concrete surfaces had minor cracking and the surface was weathered but they didn't pose any threats to the integrity of the structure.

View of the weir and the concrete surface during 2015 inspection.

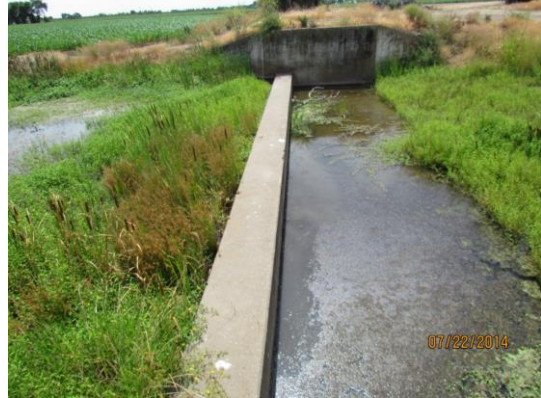
Photo 2 of 2 : ST_2015_NA0017_5_15_20150710_00009.jpg

LM Start	0.00	Rating **	A	Issue No.	15 (cont)	
LM End	0.00	Issue Type +	Ma	Location *		
Category	Structures & Concrete Lined Channels			GPS Latitude/Longitude		
				Start		End
Item	Concrete Surfaces			37.938383 °		37.938383
				-120.990133 °		-120.990133
DWR ID	DWR_NA0017_5_t_2012_15					
Action/Comments						
Inspector Comments: The concrete surfaces had minor cracking and the surface was weathered but they didn't pose any threats to the integrity of the structure.

View of the weir and the concrete surface during 2014 inspection.

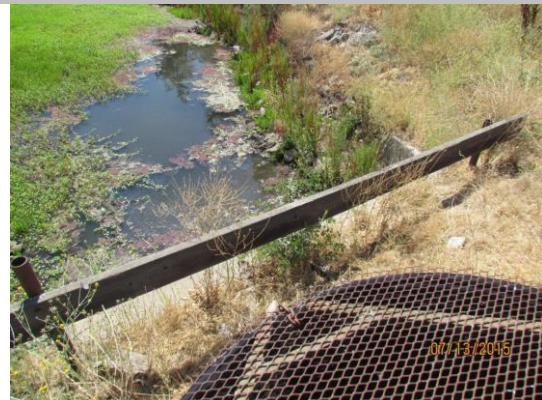
Photo 1 of 1 : ST_2015_NA0017_5_23_20150724_00020.jpg

LM Start	0.00	Rating **	A	Issue No.	23
LM End	0.00	Issue Type +	Ma	Location *	
Category	Structures & Concrete Lined Channels			GPS Latitude/Longitude	
				Start	End
Item	Safety			37.938383 °	37.938383 °
				-120.990133 °	-120.990133 °
DWR ID	DWR_NA0017_5_t_2012_23				
Action/Comments					
Inspector Comments: The wood railing top of the culvert appeared to provide adequate protection against fall hazards.

View of the railing top of the culvert.

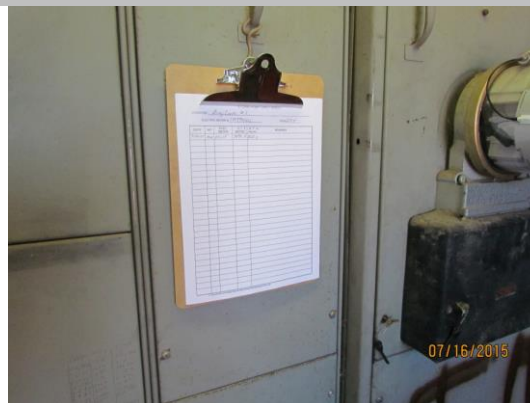
Photo 1 of 1 : ST_2015_NA0017_18_1_20150720_00014.jpg

View of the operation log in the plant.

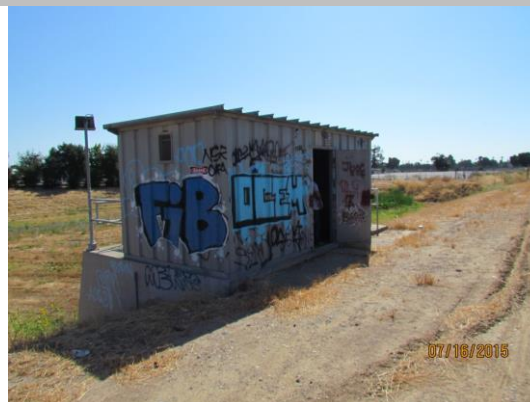
Photo 1 of 1 : ST_2015_NA0017_18_3_20150720_00015.jpg

LM Start	0.00	Rating **	A	Issue No.	3	
LM End	0.00	Issue Type +	Ma	Location *		
Category	Pump Stations			GPS Latitude/Longitude		
				Start	End	
Item	Plant Building			37.989633 °	37.989633 °	
				-121.266933 °	-121.266933 °	
DWR ID	DWR_NA0017_18_t_2012_3					
Action/Comments						
Inspector Comments: The plant building was in good structural condition.

View of the pumping plant.

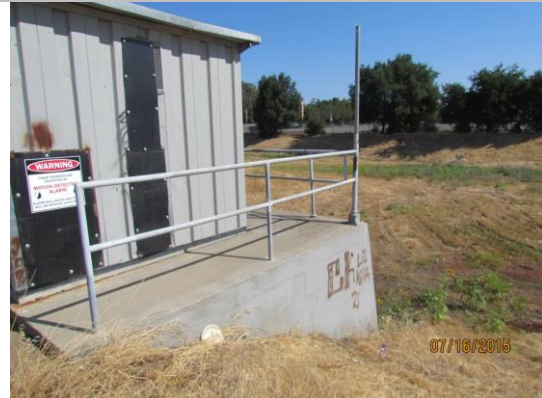
Photo 1 of 1 : ST_2015_NA0017_18_5_20150720_00016.jpg

LM Start	0.00	Rating **	A	Issue No.	5
LM End	0.00	Issue Type +	Ma	Location *	
Category	Pump Stations			GPS Latitude/Longitude	
				Start	End
Item	Safety			37.989633 °	37.989633 °
				-121.266933 °	-121.266933 °
DWR ID	DWR_NA0017_18_t_2012_5				
Action/Comments					
Inspector Comments: There were no safety hazards found around the structure and the guard rails around the structure were in good condition.

View of the guard rails around the plant.

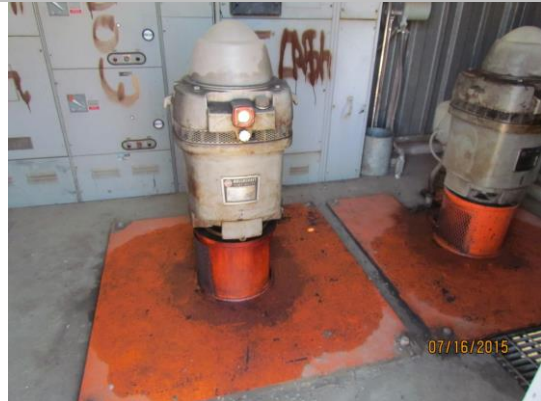
Photo 1 of 3 : ST_2015_NA0017_18_7_20150720_00017.jpg

LM Start	0.00	Rating **	A	Issue No.	7
LM End	0.00	Issue Type +	Ma	Location *	
Category	Pump Stations	GPS Latitude/Longitude			
		Start	End		
Item	Pumps	37.989633 °	37.989633		
		-121.266933 °	-121.266933		
DWR ID	DWR_NA0017_18_t_2012_7				
Action/Comments					
Inspector Comments: All pumps appeared to be in working condition and they were maintained, lubricated and tested periodically.

View of one of the pump inside the plant.

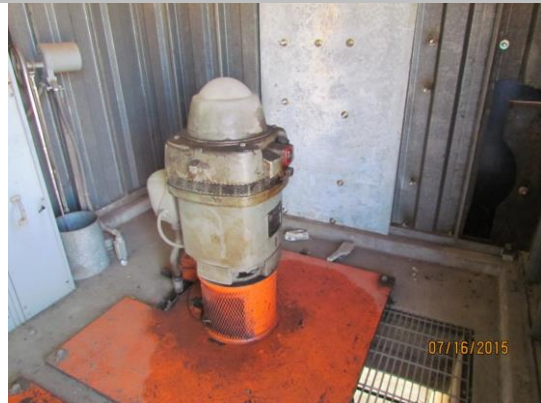
Photo 2 of 3 : ST_2015_NA0017_18_7_20150720_00018.jpg

View of another pump inside the plant.

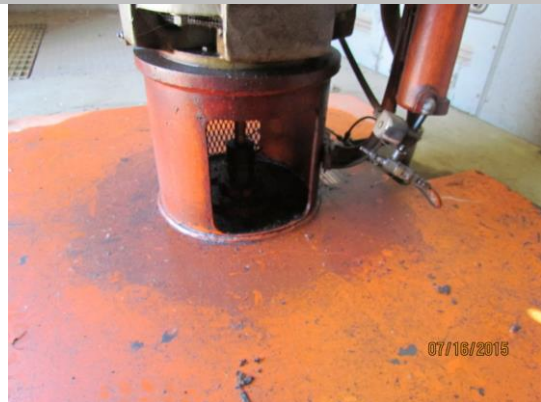
Photo 3 of 3 : ST_2015_NA0017_18_7_20150720_00026.jpg

View of the metallic shaft below a pump inside the plant.

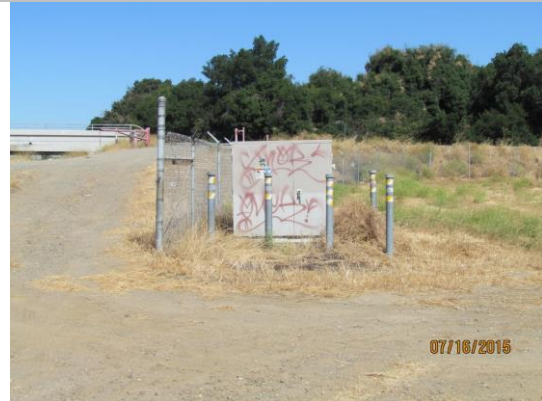
Photo 1 of 1 : ST_2015_NA0017_18_8_20150720_00019.jpg

View of the power source next to the pumping plant.

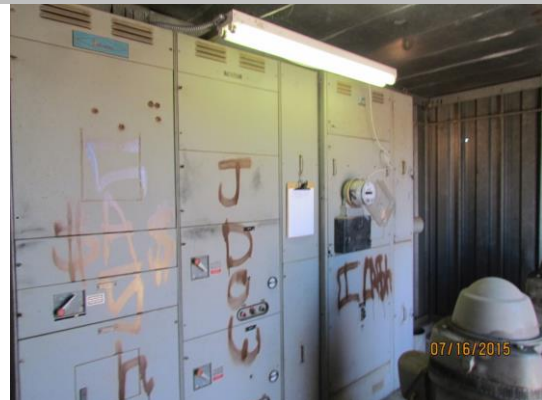
Photo 1 of 1 : ST_2015_NA0017_18_11_20150720_00020.jpg

LM Start	0.00	Rating **	A	Issue No.	11
LM End	0.00	Issue Type +	Ma	Location *	
Category	Pump Stations			GPS Latitude/Longitude	
				Start	End
Item	Pump Control Systems			37.989633 °	37.989633 °
				-121.266933 °	-121.266933 °
DWR ID	DWR_NA0017_18_t_2012_11				
Action/Comments					
Inspector Comments: The pump control systems were maintained properly and appeared to be free of damage eventhough vandalism occurred a few months ago.

View of the pump control system inside the plant.

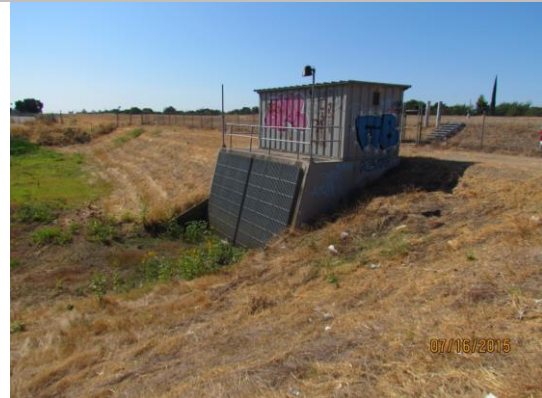
Photo 1 of 1 : ST_2015_NA0017_18_13_20150720_00021.jpg

View of the trash racks.

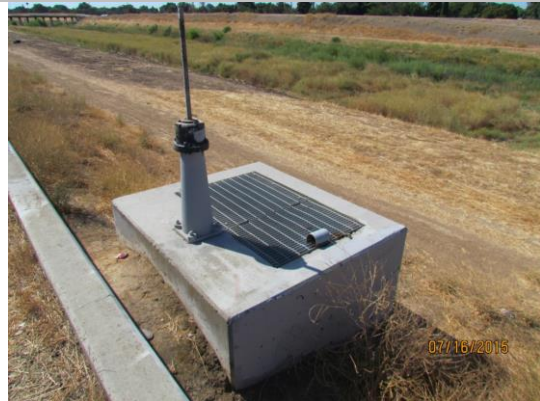
Photo 1 of 1 : ST_2015_NA0017_18_15_20150720_00022.jpg

LM Start	0.00	Rating **	A	Issue No.	15
LM End	0.00	Issue Type +	Ma	Location *	
Category	Pump Stations			GPS Latitude/Longitude	
				Start	End
Item	Sluice / Slide Gates			37.989633 °	37.989633
				-121.266933 °	-121.266933
DWR ID	DWR_NA0017_18_t_2012_15				
Action/Comments					
Inspector Comments: The slide gate appeared to be in good condition.

View of the slide gate.

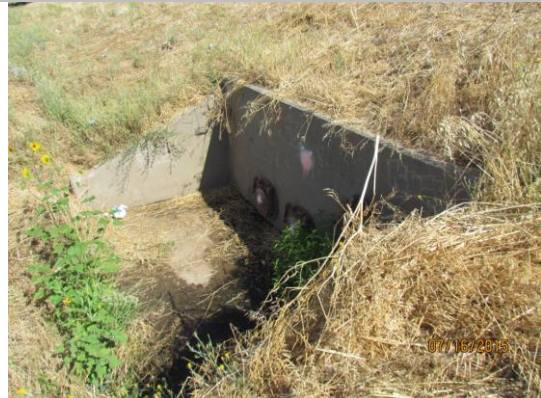
Photo 1 of 1 : ST_2015_NA0017_18_19_20150720_00024.jpg

LM Start	0.00	Rating **	A	Issue No.	19
LM End	0.00	Issue Type +	Ma	Location *	
Category	Pump Stations			GPS Latitude/Longitude	
				Start	End
Item	Flap Gates			37.989633 °	37.989633 °
				-121.266933 °	-121.266933 °
DWR ID	DWR_NA0017_18_t_2012_19				
Action/Comments					
Inspector Comments: The flap gates appeared to be in good working condition.

View of the flap gates.

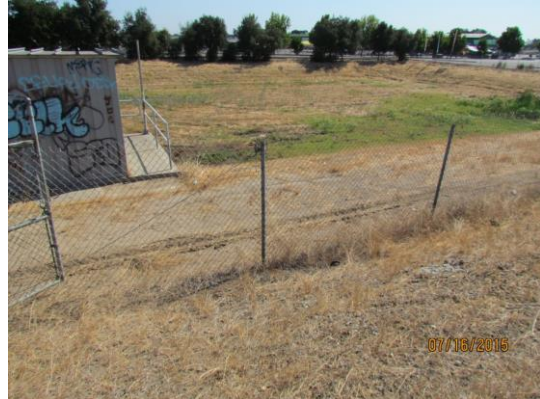
Photo 1 of 1 : ST_2015_NA0017_18_21_20150720_00025.jpg

View of the security fence around the pumping plant.

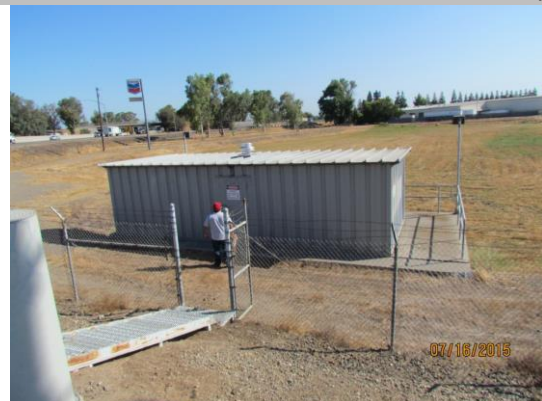
Photo 1 of 1 : ST_2015_NA0017_19_3_20150720_00014.jpg

LM Start	0.00	Rating **	A	Issue No.	3	
LM End	0.00	Issue Type +	Ma	Location *		
Category	Pump Stations			GPS Latitude/Longitude		
				Start	End	
Item	Plant Building			37.982317 °	37.982317 °	
				-121.249433 °	-121.249433 °	
DWR ID	DWR_NA0017_19_t_2012_3					
Action/Comments						
Inspector Comments: The plant building was in good structural condition without any major deficiencies.

View of the pumping plant.

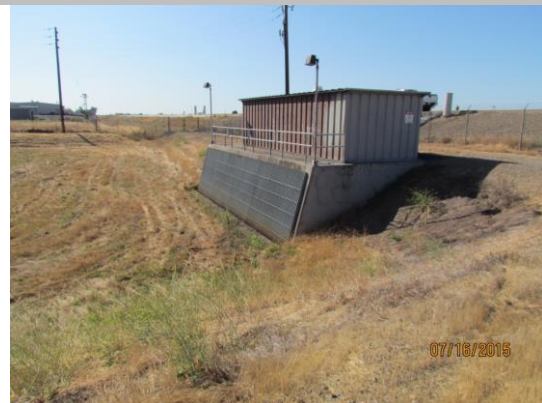
Photo 1 of 1 : ST_2015_NA0017_19_13_20150720_00021.jpg

LM Start	0.00	Rating **	A	Issue No.	13
LM End	0.00	Issue Type +	Ma	Location *	
Category	Pump Stations			GPS Latitude/Longitude	
				Start	End
Item	Trash Racks			37.982317 °	37.982317 °
				-121.249433 °	-121.249433 °
DWR ID	DWR_NA0017_19_t_2012_13				
Action/Comments					
Inspector Comments: Trash racks were properly maintained and free of any debris.

View of the trash racks.
